# MEMO

<b>TO</b>	Gary Peacock – Bath and North East Somerset Council Dale Mynett – Bath and North East Somerset Council	<b>FROM</b>	Liam Hennessey - WSP
<b>DATE</b>	28 March 2022	<b>CONFIDENTIALITY</b>	Public
<b>SUBJECT</b>	Cleveland Bridge – Truss 4 North End – Support Defect – Interim Commentary

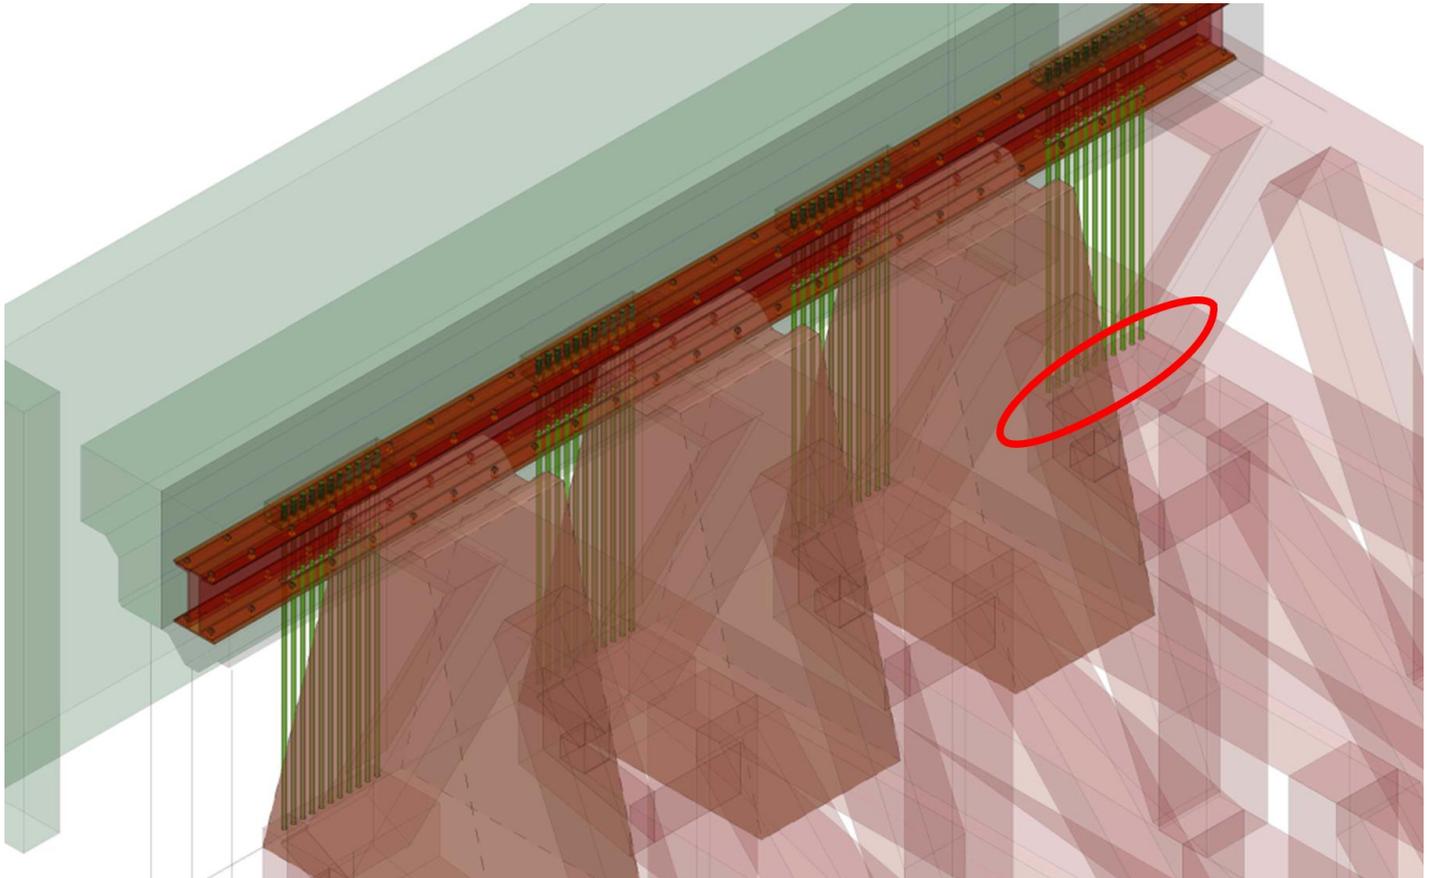
*Figure 2 - Defect location.*

A series of defects were identified in January 2022 at the lower end of the hanger bars at the north end of Truss No.4 (area circled in Figure 2). These can be attributed to corrosion of the hanger bars within the original cover concrete at their interface with the top of the truss bottom chord, as a result of persistent water leakage over a protracted period of time.

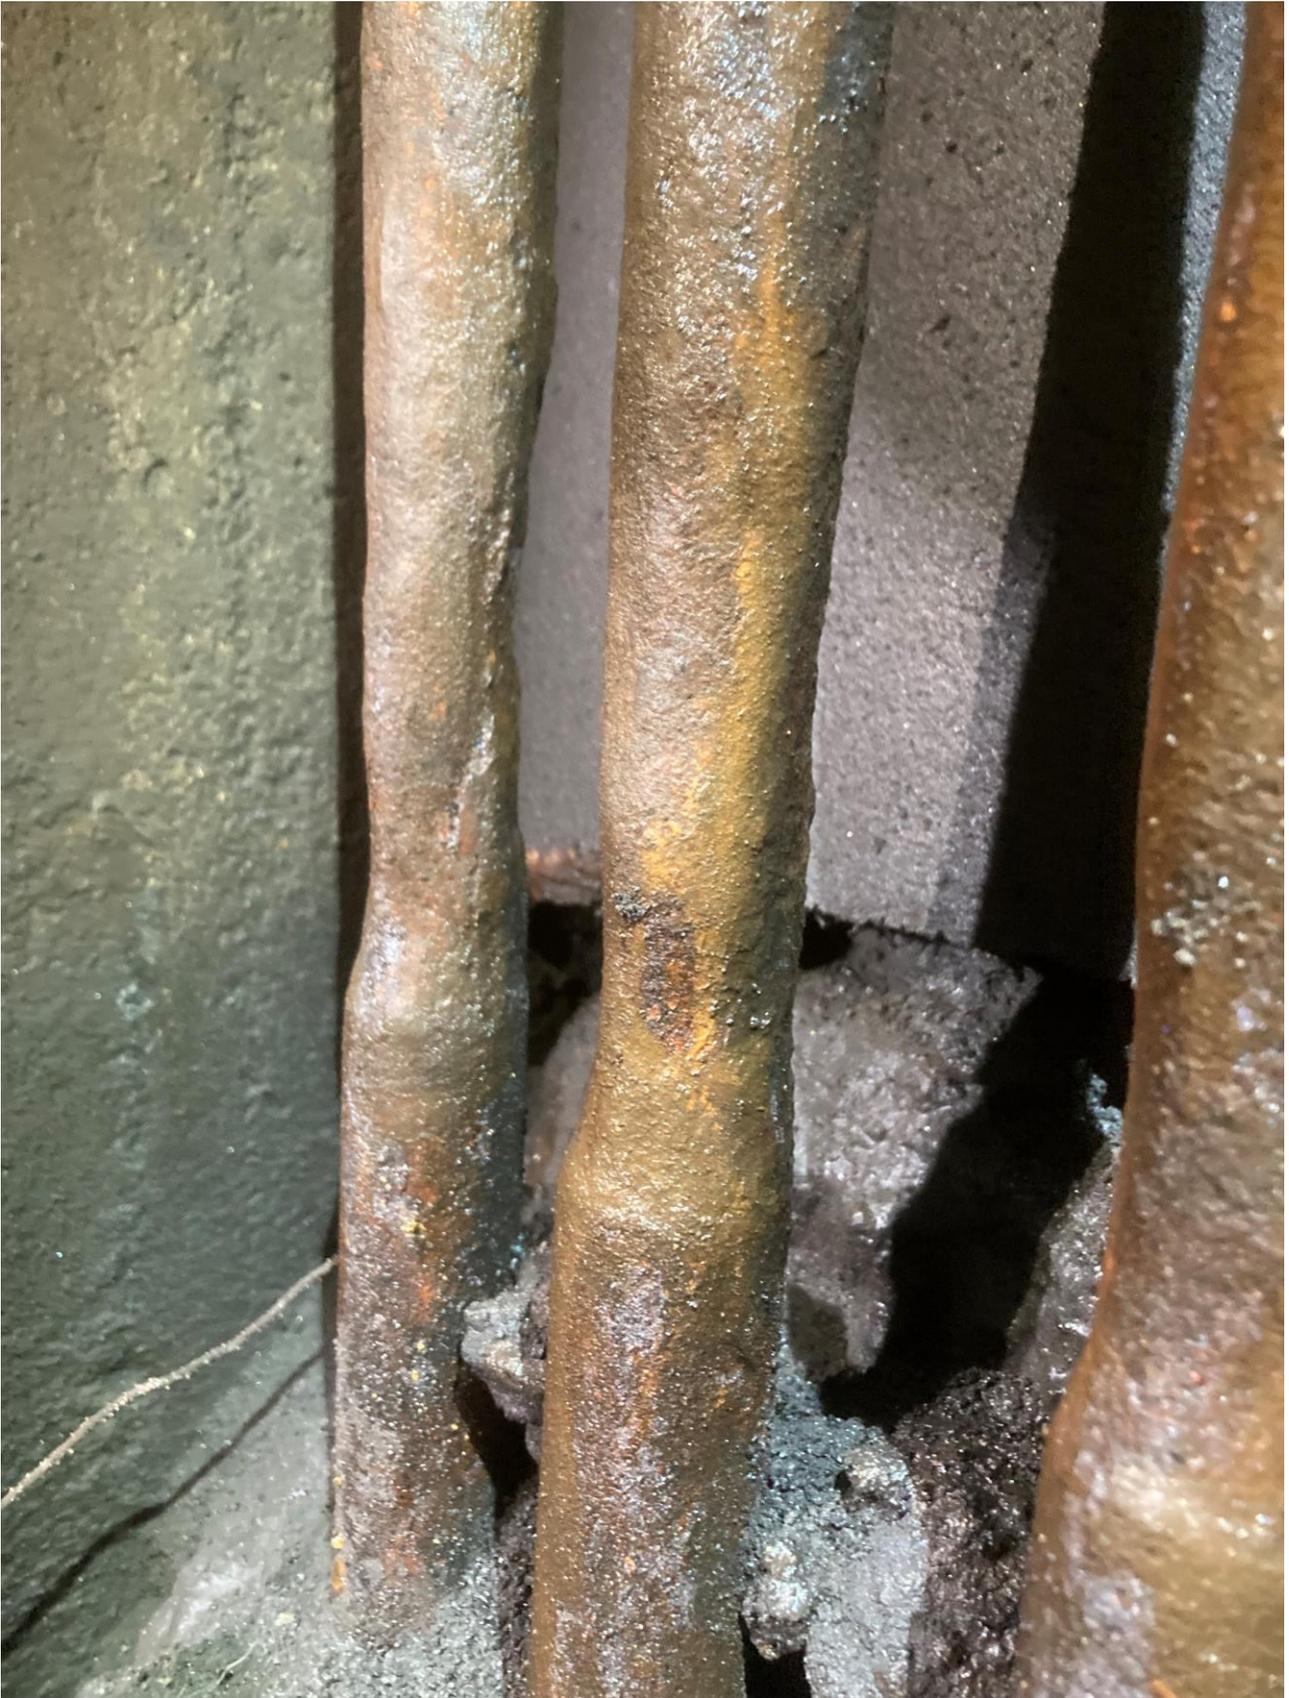
Direct measurements of the corrosion defects have identified significant levels of section loss, as illustrated in Figure 3, but further and more detailed quantification of section loss is proposed in order to refine the assessment work undertaken to date.

*Figure 3 - Close up photograph of hanger bars to the north end of Truss No.4.*

Our initial analyses have suggested that the structure is no longer capable of sustaining its current load rating of 18 tonnes, as a result of the section loss to the hanger bars. Quantitative assessment and checks are ongoing to determine the capacity of adjacent elements and what the implications of the defects are on the overall structural integrity of the bridge.

- i. Evaluation of the tensile forces within individual hanger bars based on measurements of their natural frequencies and vibrational mode shapes.
- ii. Impressions will be taken of the areas of severe corrosion to the hangers to the north end of Truss No.4 in order to more accurately evaluate the degree of section loss suffered by individual bars.

3. The feasibility study should be further developed to identify viable options for remedial works that will mitigate the risk of failure of the corroded hanger bars. The study will consider and evaluate the merits of installing a passive, failsafe support system in parallel with the ongoing monitoring system against the potential risks associated with the option of providing an active, alternative support system via bearings installed beneath the truss bottom chord. The detailed design of the preferred option will be covered by a separate Approval in Principal process and subject to an appropriate level of checking.
