STREETSCAPE AND DETAILS

45 HIGH STREET, KEYNSHAM

53 HIGH STREET, KEYNSHAM

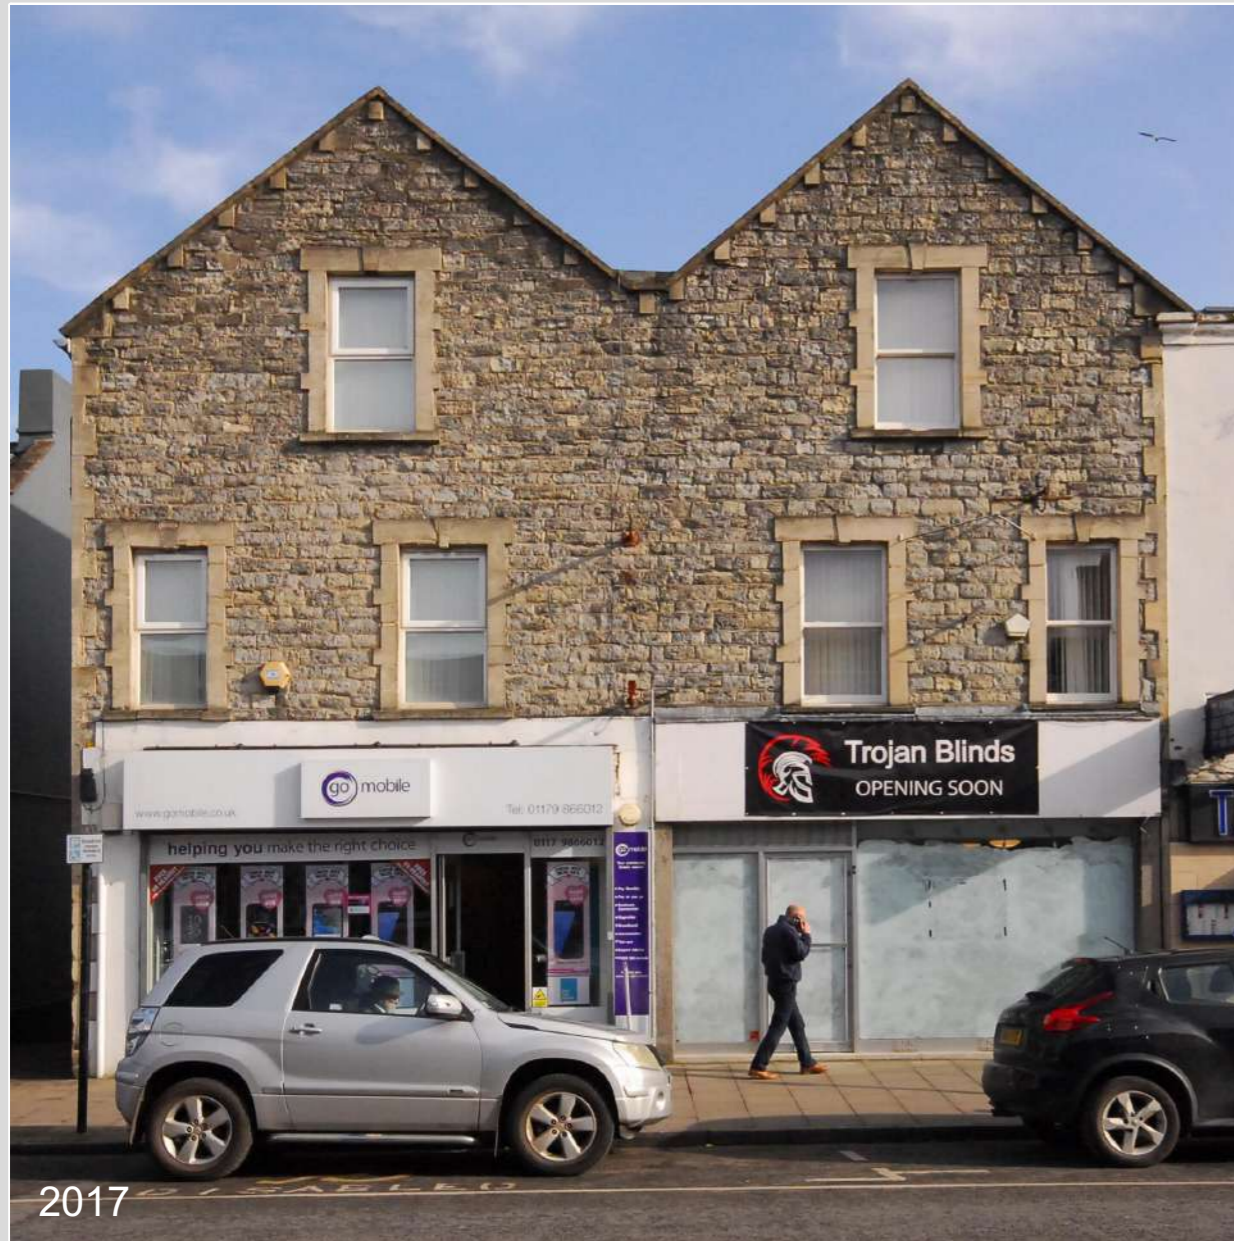
2017

The current shop fronts are metal and glass with extensive signage over the openings which extend to the underside of the first floor window sills. The configuration of the frontages bears no relation to the architecture above or to historic shop fronts.

The buildings original design was awkward due to the placement of windows; however this made sense when the original bays and doors were in place. The loss of the ground floor architecture and its replacement with continuous openings and modern frontages has not improved matters. The condition of the building is fair but the shop fronts are poor.

The shop fronts currently detract from the street scene and could be enhanced by:

- Form new planted shop fronts within confines of existing openings
- Ensure the party pier and stonework above should be fully exposed
- Stone to sides of openings should be exposed
- Signage to be consistent in size across both buildings. Should not extend beyond openings
- Render over shopfronts removed
- Shopfront openings should relate to windows above
- Reintroduction of timber sashes to 41

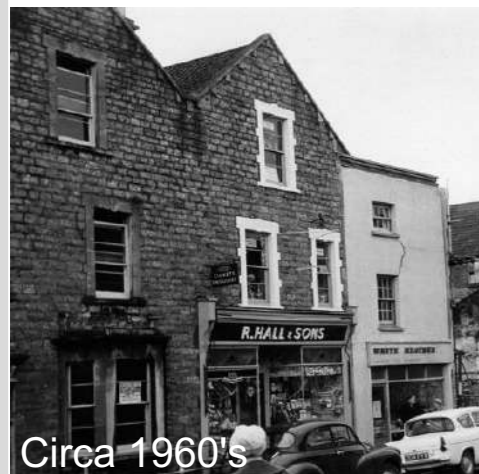
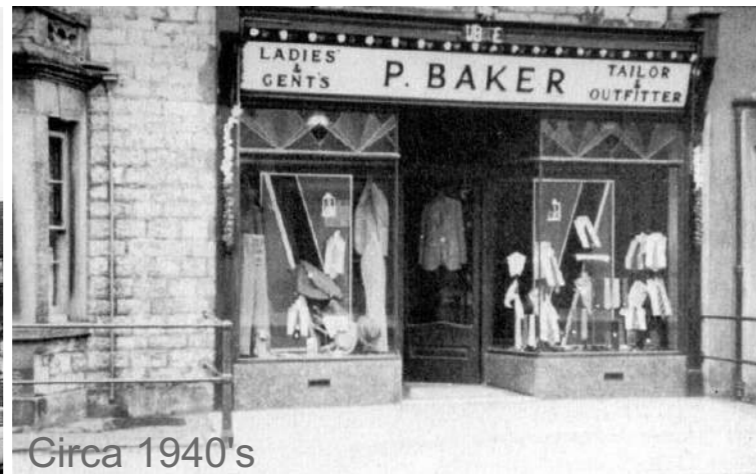
41 and 43 High Street Keynsham form a single construction comprising 2 units circa mid to late 1800's. Originally dwellings, over 3 storeys the building unusually have their gables facing the street. Built in local lias stone and detailed with Bath stone quoins, sills, window surrounds and gable copings with stepping blocks, the elevation is symmetrical around the central valley. The attic storey has a single 1/1, and the first floor 2 smaller windows 1/1 timber sashes since replaced with uPVC to 41.

Originally entrance doors and bay windows were set below the first floor openings. In the case of 43 the bay and entrance door were replaced with a traditional shop front. All traces of doors bays and shop fronts have been lost and the ground floor frontage opened up with the introduction of modern shop fronts.

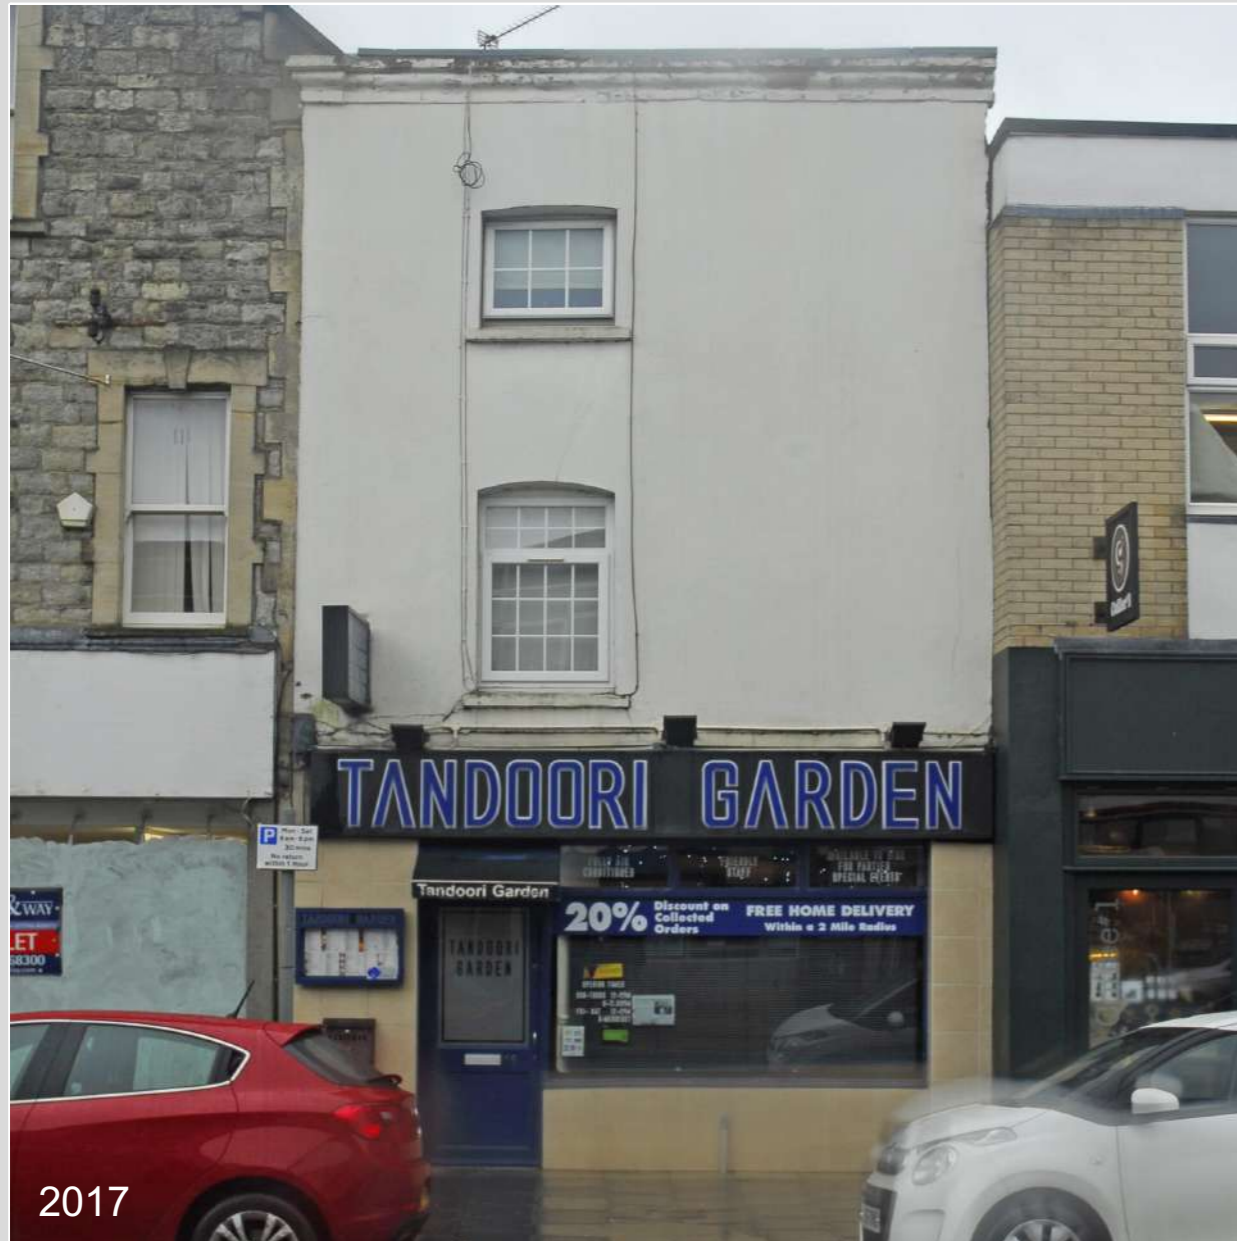
2017

The current building retains some original features including the stone cornice but has been severely compromised by the loss of 47. The windows have been changed to uPVC and the arch heads segmented since 1960. There are numerous services running across the elevation. At ground level signage runs the width of the building and the stall riser and remaining masonry have been ceramic tiled.

The loss of the companion building has impacted on the balance of the elevation. A number of small changes have also eroded the character, especially at low level. The condition is fair and the building would benefit from targeted work.

This building was never intended to have a shop front so balancing the entire elevation will be difficult, however a number of improvement are possible:

- Remove tiling from elevation and continue upper floor decoration down to the ground
- Form planted shop front to width of existing opening
- Re-route of service wires internally
- Strip paint off stone cornice
- Replace uPVC windows with timber sashes
- Restrict signage to width of shop opening
- Change the signage to traditional style timber fascia

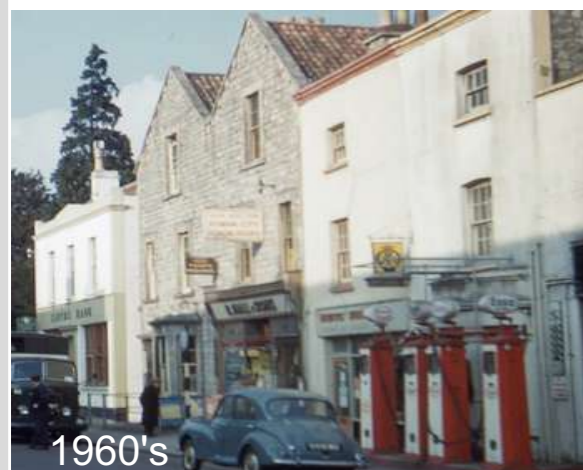
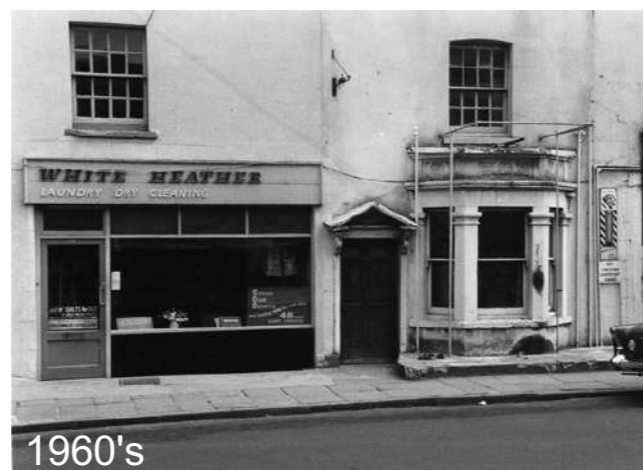
45 High Street Keynsham originally formed the left hand side of a block of 2 with 47. Both 19th century dwellings. Ranged over 3 floors the elevation was symmetrical about the party wall and comprised a rendered elevation topped with a moulded stone cornice below which a single range of windows to each unit comprise 4/4 and 8/8 timber sliding sashes. Steps in the cornice suggest pilasters on the abutments. At ground floor level open pedimented doorcases over door openings sat against the party wall and bay windows sat below the upper floor windows. In the case of 47 these were extant in the 1960's prior to demolition.

By the 1950's No 45 had lost its ground floor architecture which had been replaced with an open shop front with stall riser, transom window and plate glass display window.

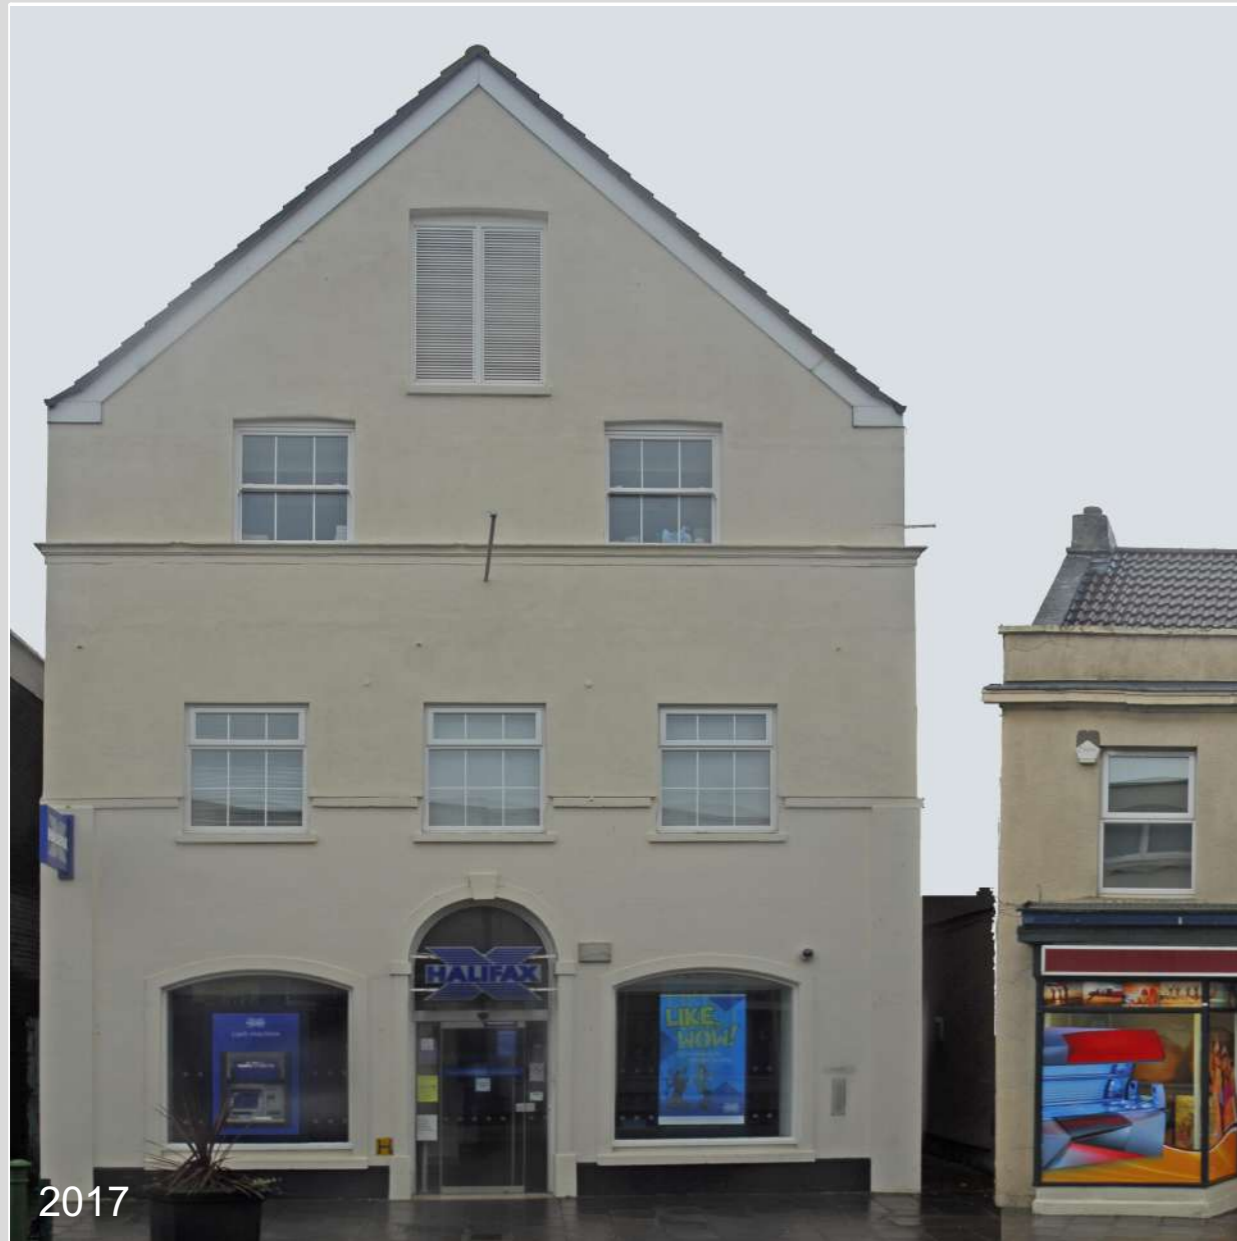
2017

The windows to the upper floor are 3/3 sashes whereas the first floor windows are 3/6 uPVC. At ground level a central arched chapel doorway is flanked by two C20th segmental arched windows.

The verge board is a clumsy plastic replacement of a traditional ornate board which originally overhung providing a strong roof line. The business signage is subtle and does not sit on the architecture.

No 53 is a product of multiple changes. It is in good repair and has a benign street presence with sensitive signage.

The size of the elevation is commanding. Its treatment as a single entity is positive however a number of unsympathetic alterations have detracted from the elevation. Further enhancements could include:

- Replacement of uPVC windows with timber sashes sub-divided with glazing bars
- Sub-division of ground windows

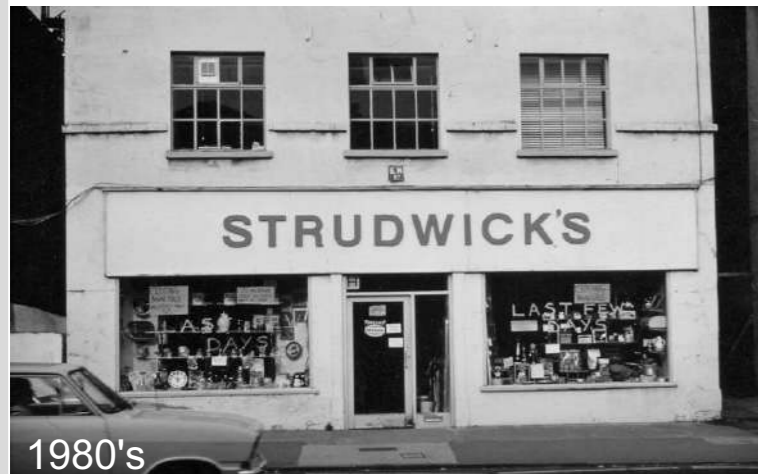
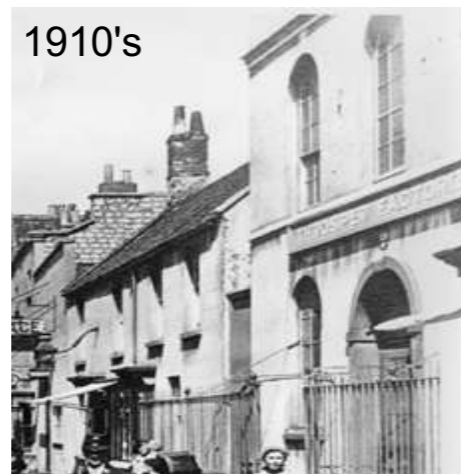
No 53 High Street Keynsham, has changed significantly throughout its history. The core of the building is early 1700's and was most likely used in manufacturing. In 1803 the building was converted to a Methodist chapel and had an upper storey and arched windows added. From 1887 it was used as the offices and by 1900 it was an eyelet factory, from 1936 onwards it was a store before becoming the Halifax after 1983. With these changes in function have come numerous alterations to the elevation particularly at ground level and to the window openings.

The building presents its gable to the street which combined with the buildings height presents a dominant presence. The 3 storeys of the building change character and there are no unifying elements as a result of multiple changes. Legacy elements of strings, cornices, and different windows have led to a patchwork elevation unified by render and decoration.

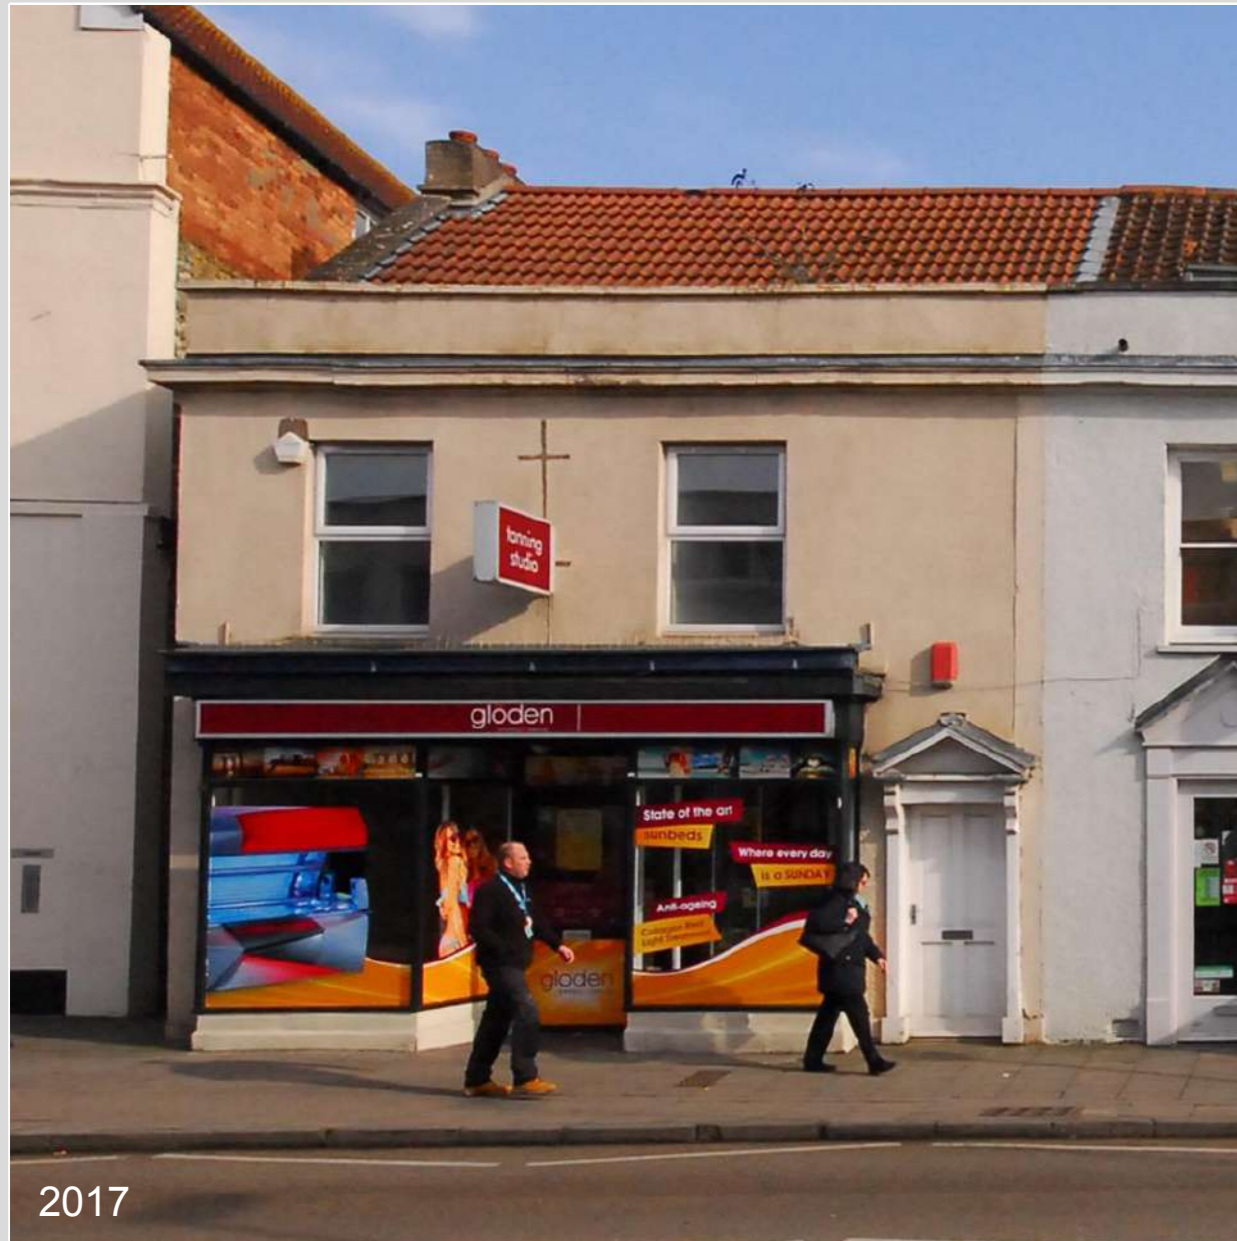
2017

No 55 High Street has its entrance to the right of the elevation. This appears original. The first floor windows are uPVC replacements of timber sashes. The ground floor elevation is a traditionally configured shop with a central recessed doorway and glazing line sitting on the original plinth. Whilst the glazing has changed with the loss of the traditional cills there appear to be elements of the original fascia and box canopy assembly.

Alarm boxes and a projecting sign slightly clutter the elevation and there has been some over rendering which is poorly resolved at the junction with 57 and over the doorcase. The shop signage whilst plastic sits within the confines of the original fascia and shop front boundaries.

On initial inspection a lot of the original fabric to the shopfront and architectural detailing remains intact and is positive. The condition of the building is good and with the exception of a few inappropriate advertisement items. The later could be improved.

This shop frontage is predominantly intact and with some considered attention could be further enhanced by:

- Removal or relocating of alarm boxes
- Replacement cantilevered illuminated sign with more traditional design
- Reinstatement of timber sash windows.
- Reintroduction of traditional glazing and cill details to shop front
- Replacement of plastic signage with traditional signwriting.
- Removal of glass applied advertising
- Review of render details to doorway and junction with 57

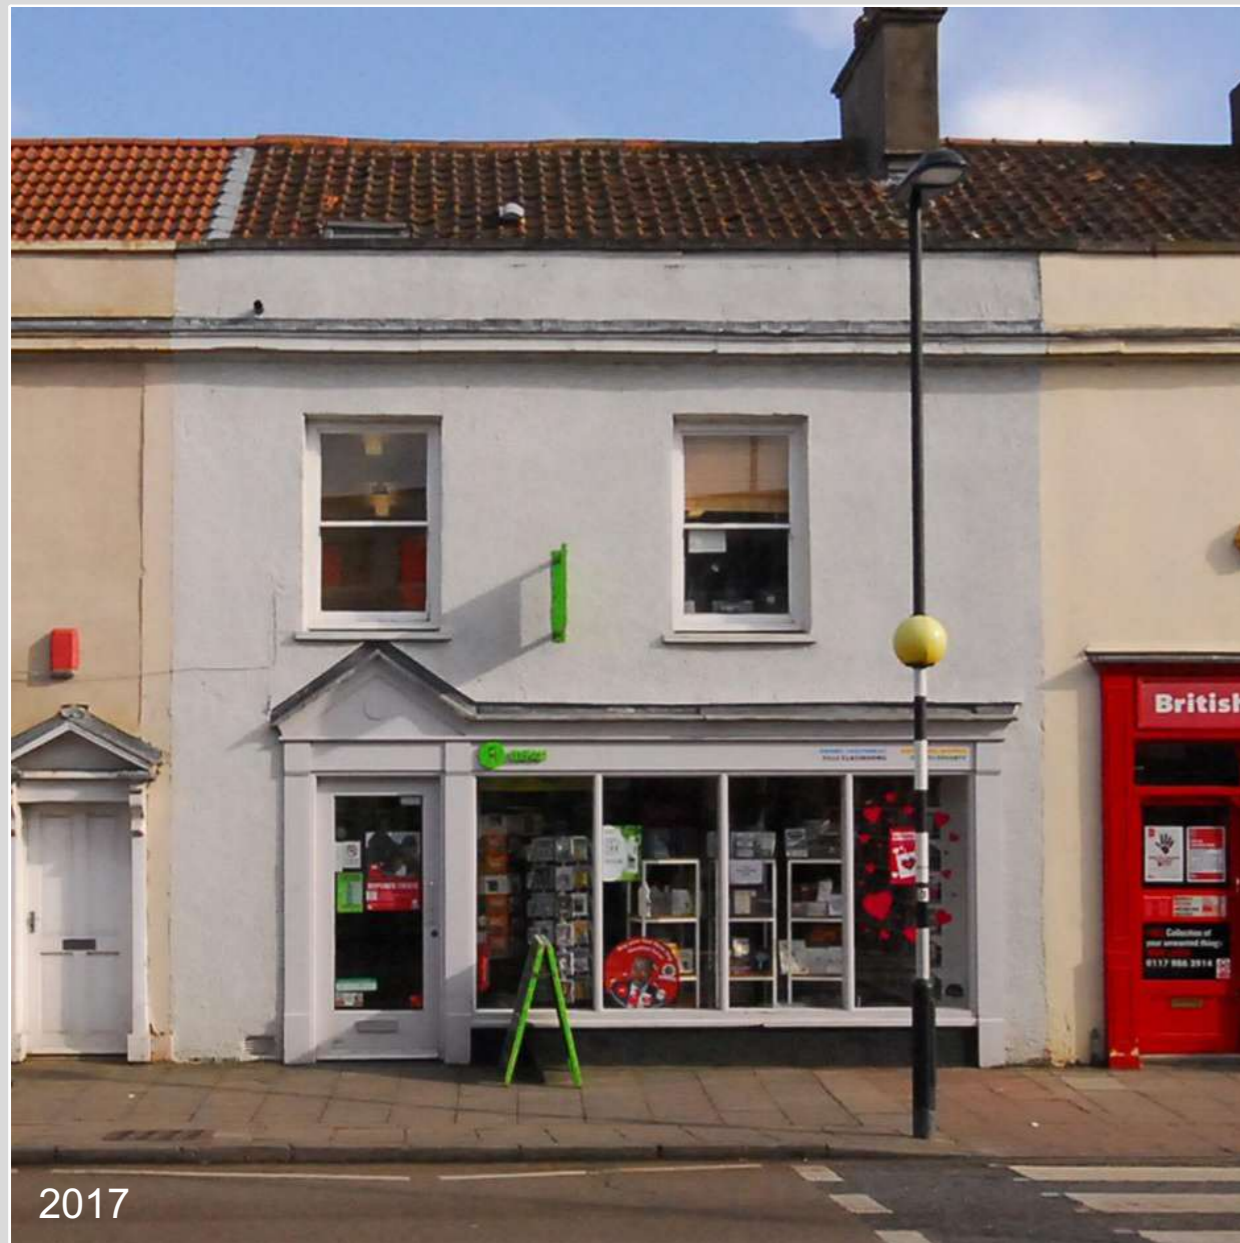
2017

Whilst an attempt has been made to make the new shopfront look traditional the scale of the door is too large and it collides awkwardly with the window cill above and draws attention away from the adjoining original doorcase. The stone plinth has been chopped back disconnecting the various building at ground level.

A significant amount of the original character of the building remains and the new shop front whilst clumsy in some respects is successful and relates to some degree to the upper storey. The signage is sensitive and minimal and the elevation is uncluttered. The use of a pediment to compete with the original to No 55 was possibly an error as it over sizes the frontage.

- This shop frontage is predominantly positive and well handled. Some additional enhancements could be made
- Removal of pediment to doorcase. Run flat moulding through
 - Reintroduction of the original plinth line
 - Decoration of planted shop front in a colour distinct from the main elevation

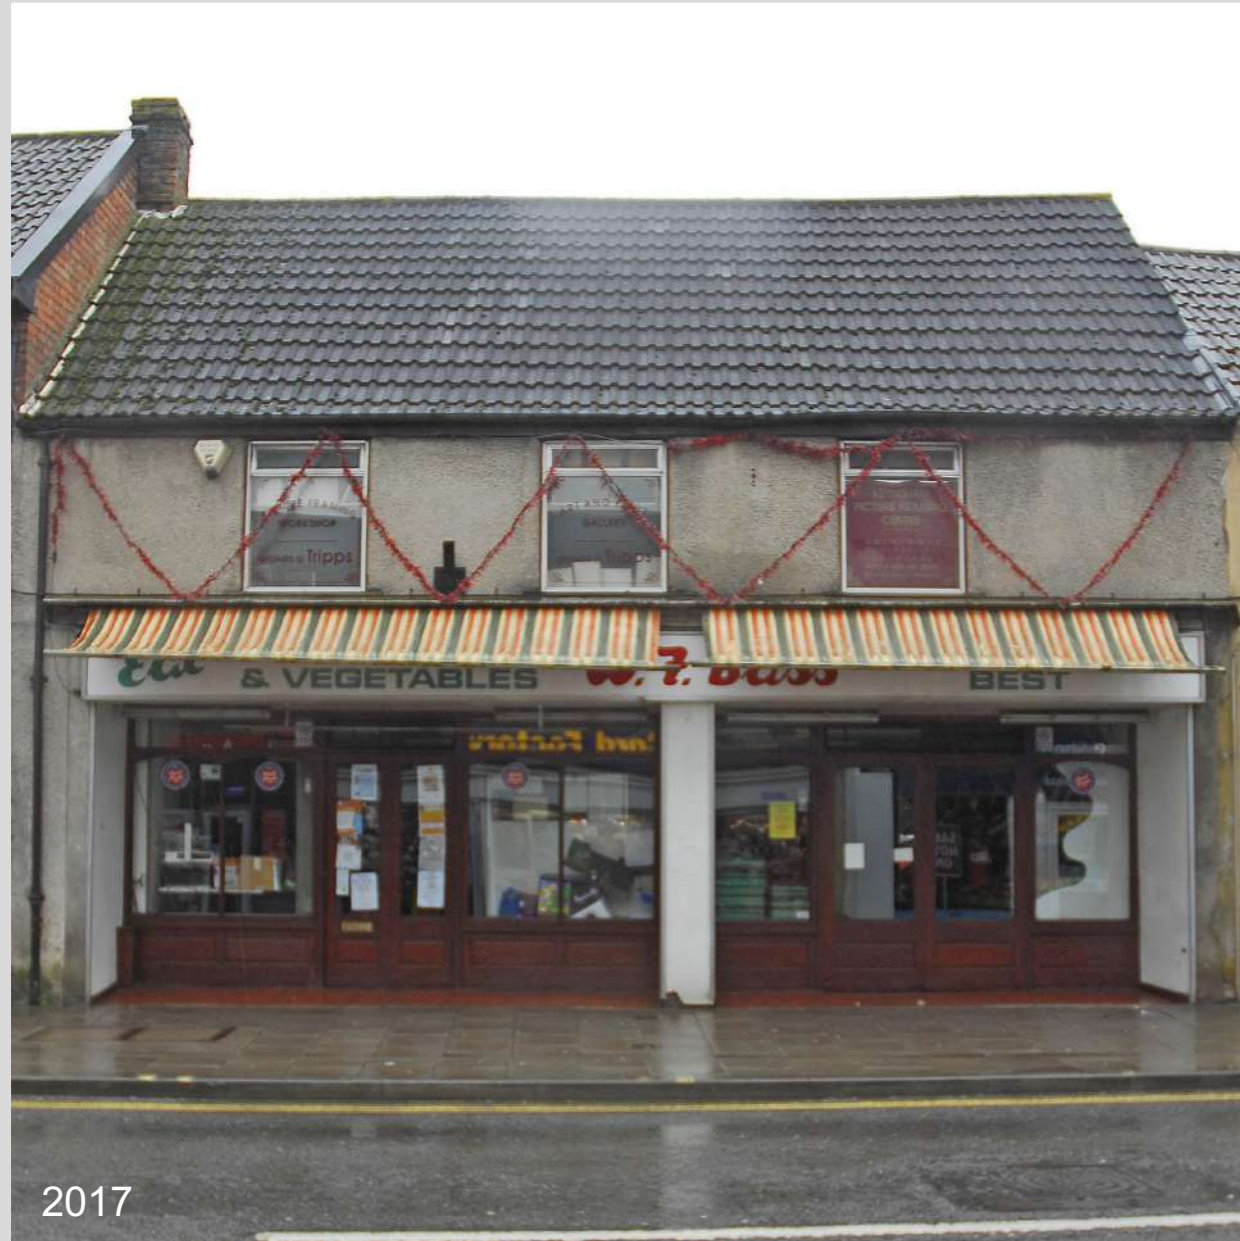
2017

The building consists of half round ridge tiles over concrete double Roman tiles discharging into a plastic gutter and cast iron downpipe. Roughcast render extends either side of the elevation down to ground level where it is terminated possibly on the remains of a stone plinth. The upper floor has 3 modern plastic windows with obscured cills.

At ground level there are two large circa 1960's structural openings separated by a pier clad in plastic. The shop frontage is recessed by several feet running the combined width of the openings. The frontage is timber framed with a fielded stall riser and different widths centred double doors to each opening. The reveals and sign above which spans the entire double opening are clad in plastic with metal trims. There is continuous box housing across the top of the fascia and 2 awnings.

The condition and integrity of the elevation is poor with a lot of inappropriate intervention. The setting back of the frontage has not only lost retail area but has destroyed the grounding of the building. There is significant opportunity for enhancement of this elevation by installing new planted shopfronts, repairing and redecorating the elevation.

This building is a candidate for major intervention

- Consider replacement of shopfronts with framed and planted designs on face of building to increase shop footprints, ground the elevation and enhance street scene.
- Reinstate traditional windows with margin glazing to upper floors
- Replace gutters with cast metal
- Remove white plastic and metal trims to surfaces
- Redecorate and repair render
- Remove surface mounted services

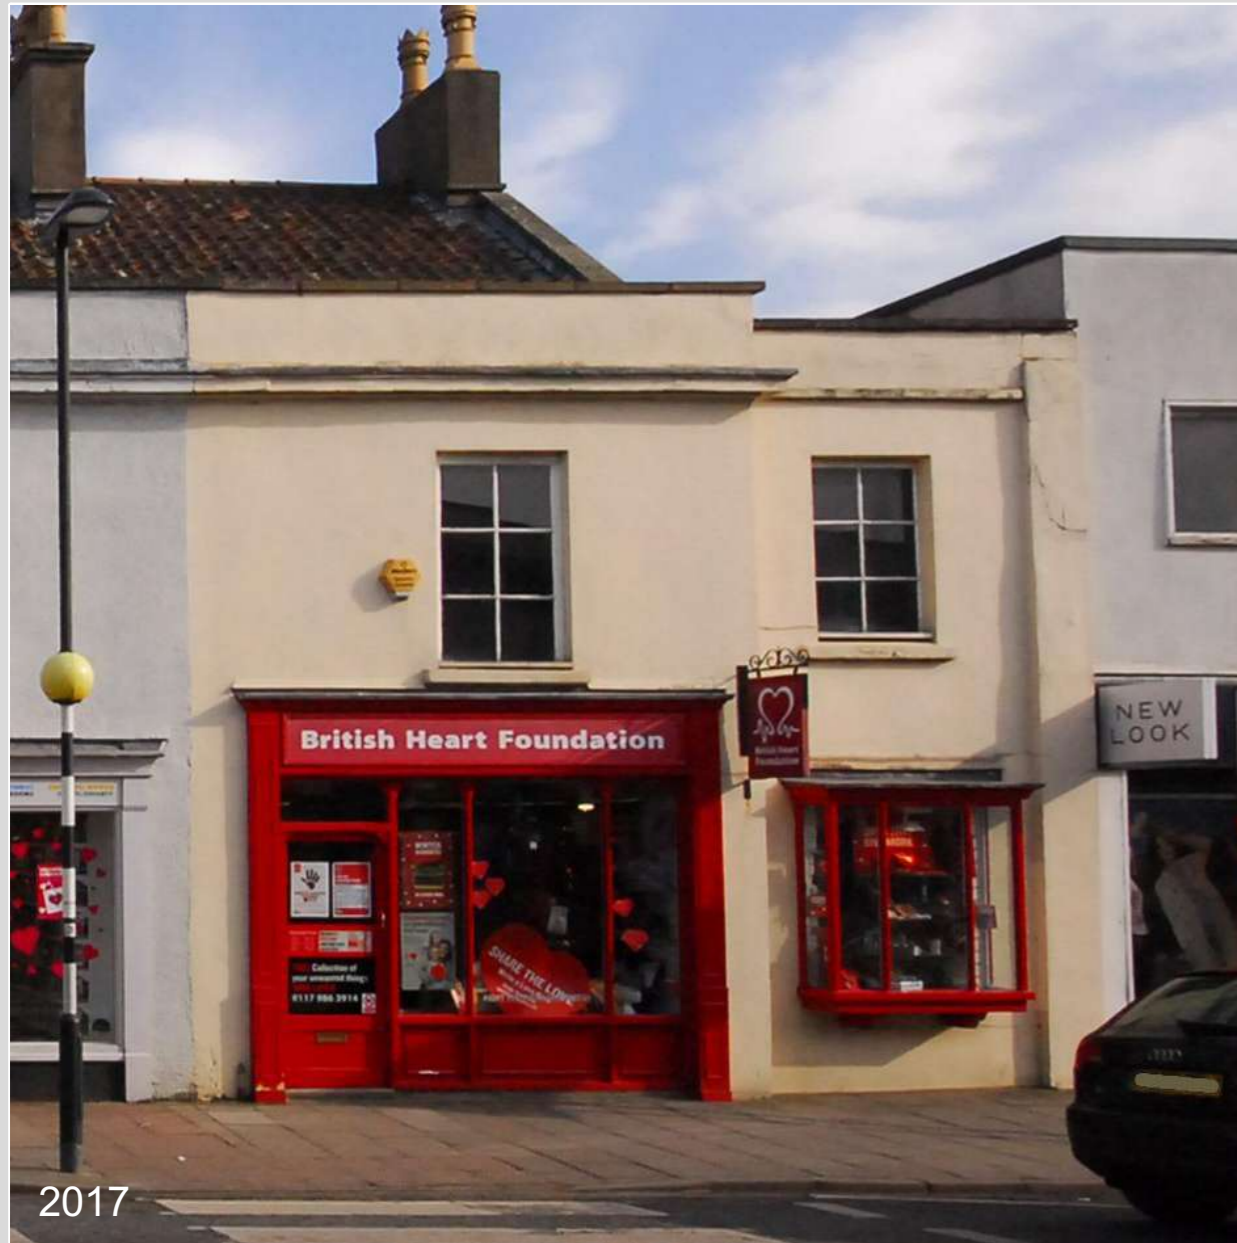
2017

The design of the frontage is a convincing interpretation of a traditional shop front being planted onto the face of the elevation enabling proportions to be adjusted. As with no 57 the plinth has been lost and the top of the frontage sits very tight to the underside of the eills but this relates well with the original frontage to No 57.

A significant amount of the original character of the building remains and the new shop front is successful in many respects. The signage is sensitive and minimal and the elevation is uncluttered.

This shop frontage serves as a good example of sensitive and appropriate intervention. The planting of the shop front onto the elevation is key. This has provided articulation of the elevation, liberated the designer from opening constraints, contained the spread of signage and helped maintain the integrity of the rest of the building by allowing decorations to extend to the pavement line grounding the building.

- Reintroduce 6/6 timber sashes to upper floors

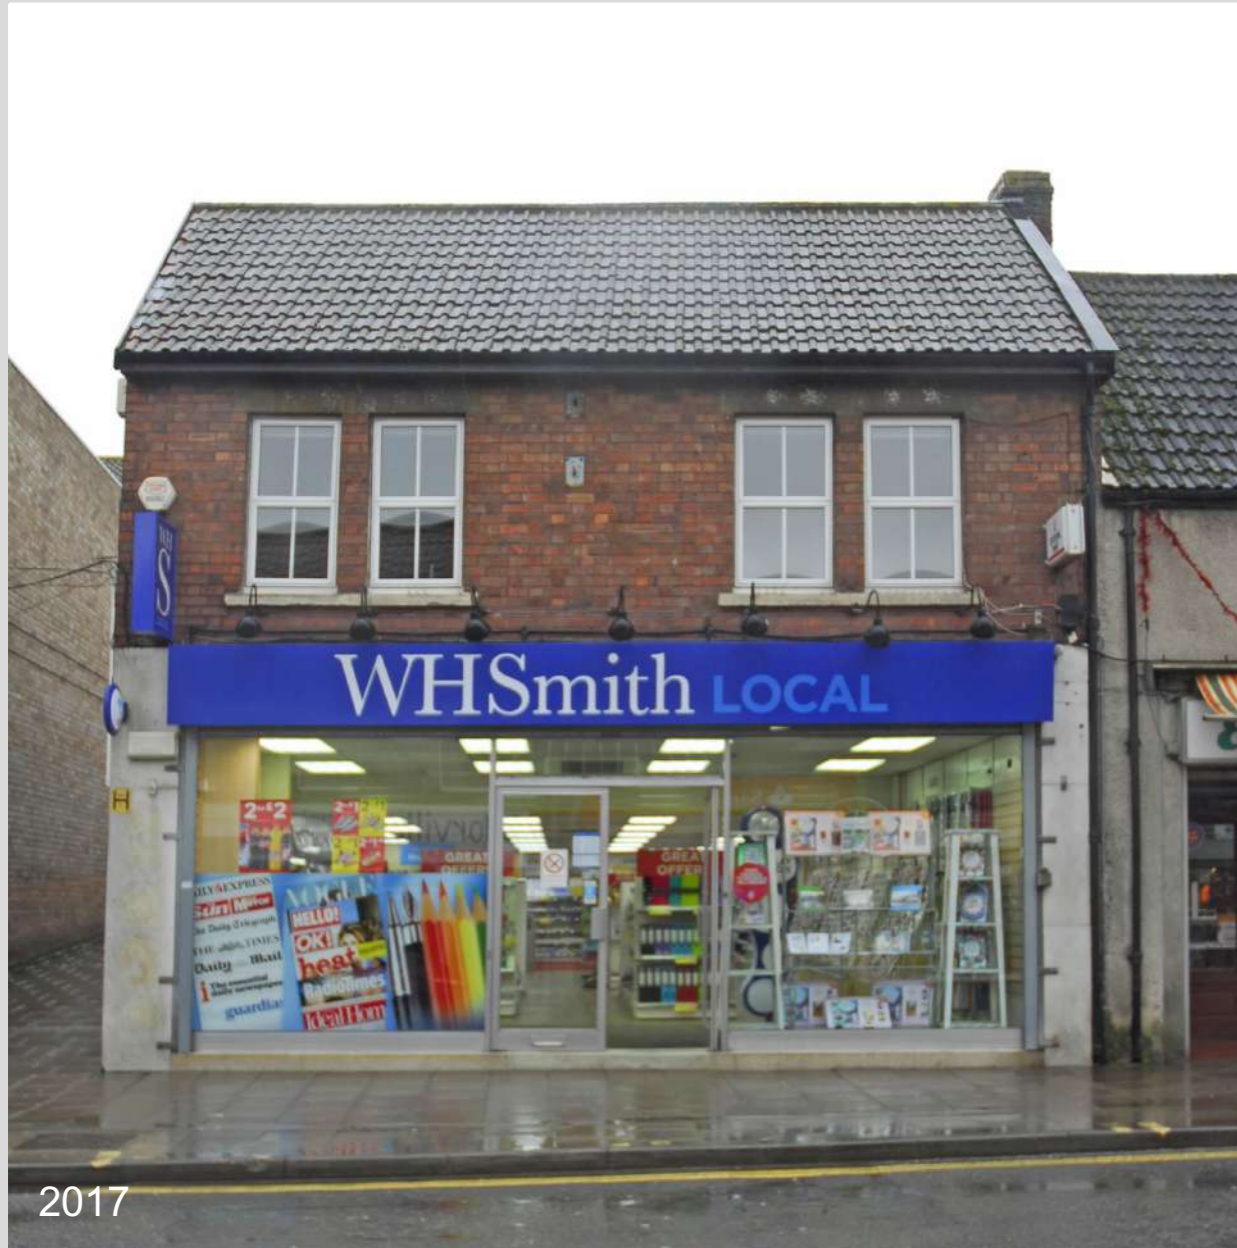
2017

60 High Street, Keynsham, is a brick built late Victorian frontage comprising a pair of double windows set symmetrically over a double Roman tiled roof discharging into cast iron rainwater goods. The windows originally 2/2 sashes have been replaced with uPVC. The shop frontage was originally 2/3 of the elevation with a cart door to the right now replaced with a single opening of metal framed glazing, stone clad sides and a projecting plastic fascia sign.

The building has limited character. The use of stone at low level either sides of the frontage is minimal. Similarly the openness of the front elevation which extends from floor to ceiling and from each party wall is aggressive creating a visual cavity in the street scape. This is exacerbated by the treatment of the interior which is evident from the street for the full depth of the shop.

This is perhaps the most open shop front on the High Street and is distracting in the street scene. It would be greatly enhanced by:

- Replacement of uPVC windows with traditional 2/2 sliding timber sashes at first floor level
- Remove stone cladding to sides of shopfront to reinstate brickwork to the ground
- Complete replacement of the shop front with a planted frontage with stall-riser and framed sides and traditional signage
- Reduced amount of glazing with internal security shutters
- Use traditional painted signage and traditional hanging signs
- Removal of swan neck lamps

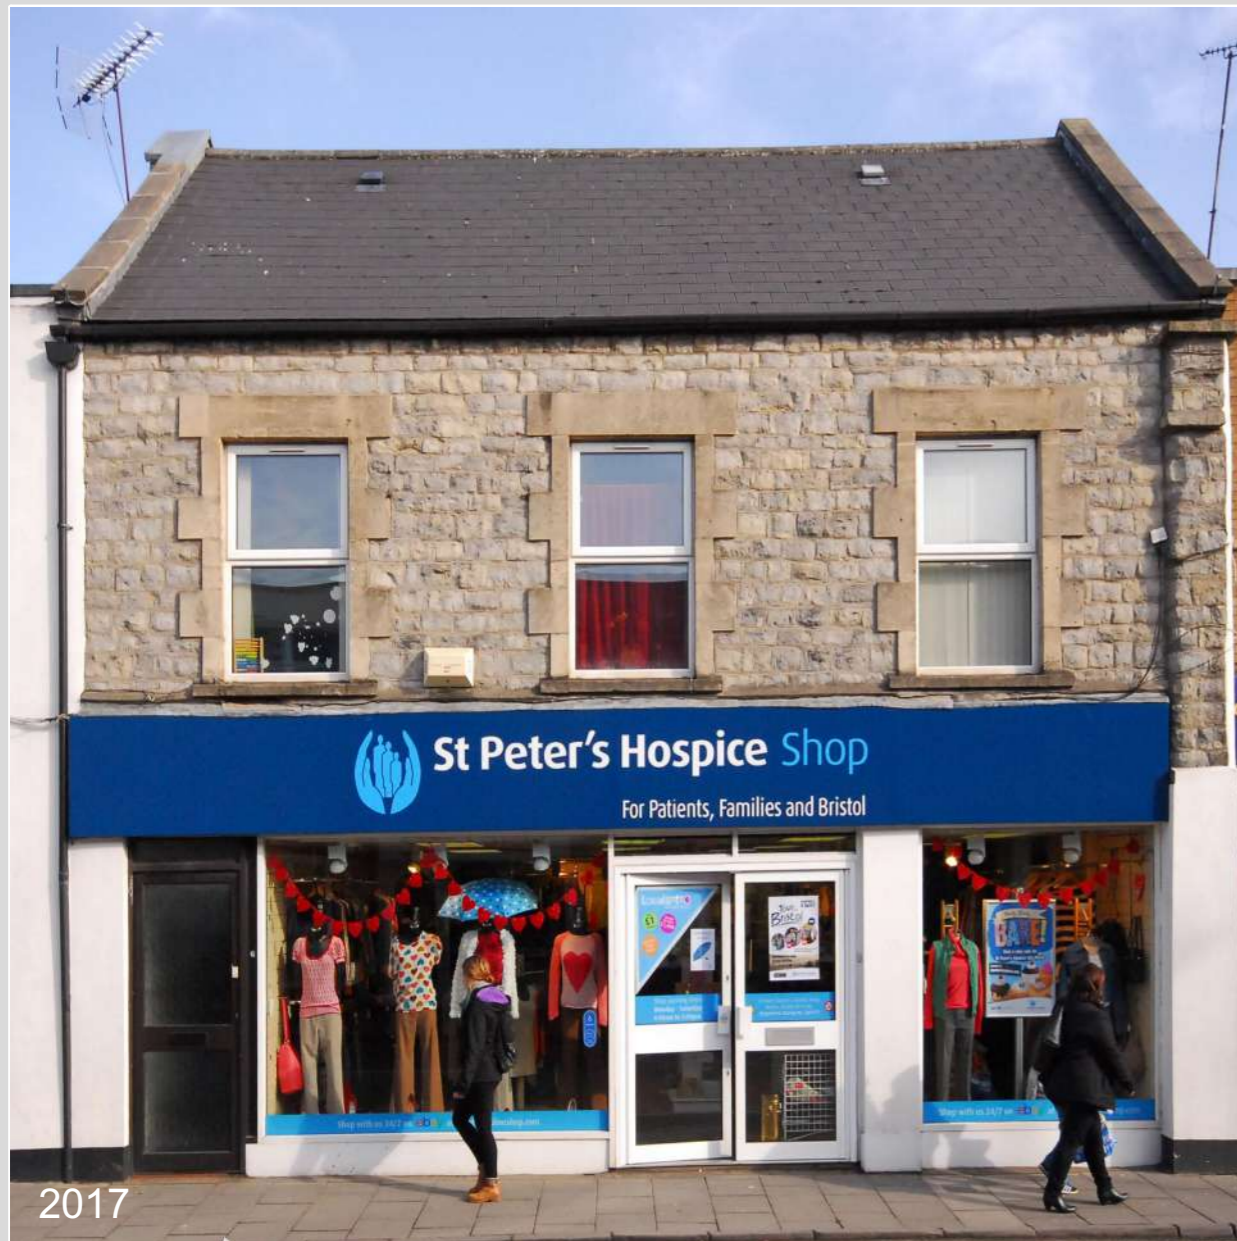
2017

The current frontage comprises plastic fascia signage running tight to the underside of the sills and the width of the elevation over plate glass windows and metal glazed doors. To the left is access to the upper floor accommodation. The former service entrance is discernible but is now part of the frontage.

The original elevation of a dwelling and a shop had only limited correlation between floors but the two functions were distinguishable. The stonework extending to the paving grounded the elevation. The current treatment of the ground floor as a single shop front with full width signage bisects the elevation. The form of the shop front with a central door provides potential for some considered intervention. The building is in reasonable condition but has suffered from the unregulated use of plastic components.

This elevation could be significantly enhanced with more considered design. The shop frontage should be limited so as not to include the door to the accommodation above and should be designed around the central doors.

- Replace first floor uPVC windows with margin 3/3 sliding timber sashes
- Replace plastic guttering and downpipes with cast metal
- Remove electrical cables from front elevation
- Form planted timber shopfront centred on shop doorway and width of unit with increased stall riser
- Remove render to side piers to ground elevation
- Replace plastic signage with painted signage
- Change door to residential accommodation to partly glazed timber door
- Limit shop frontage to unit width only

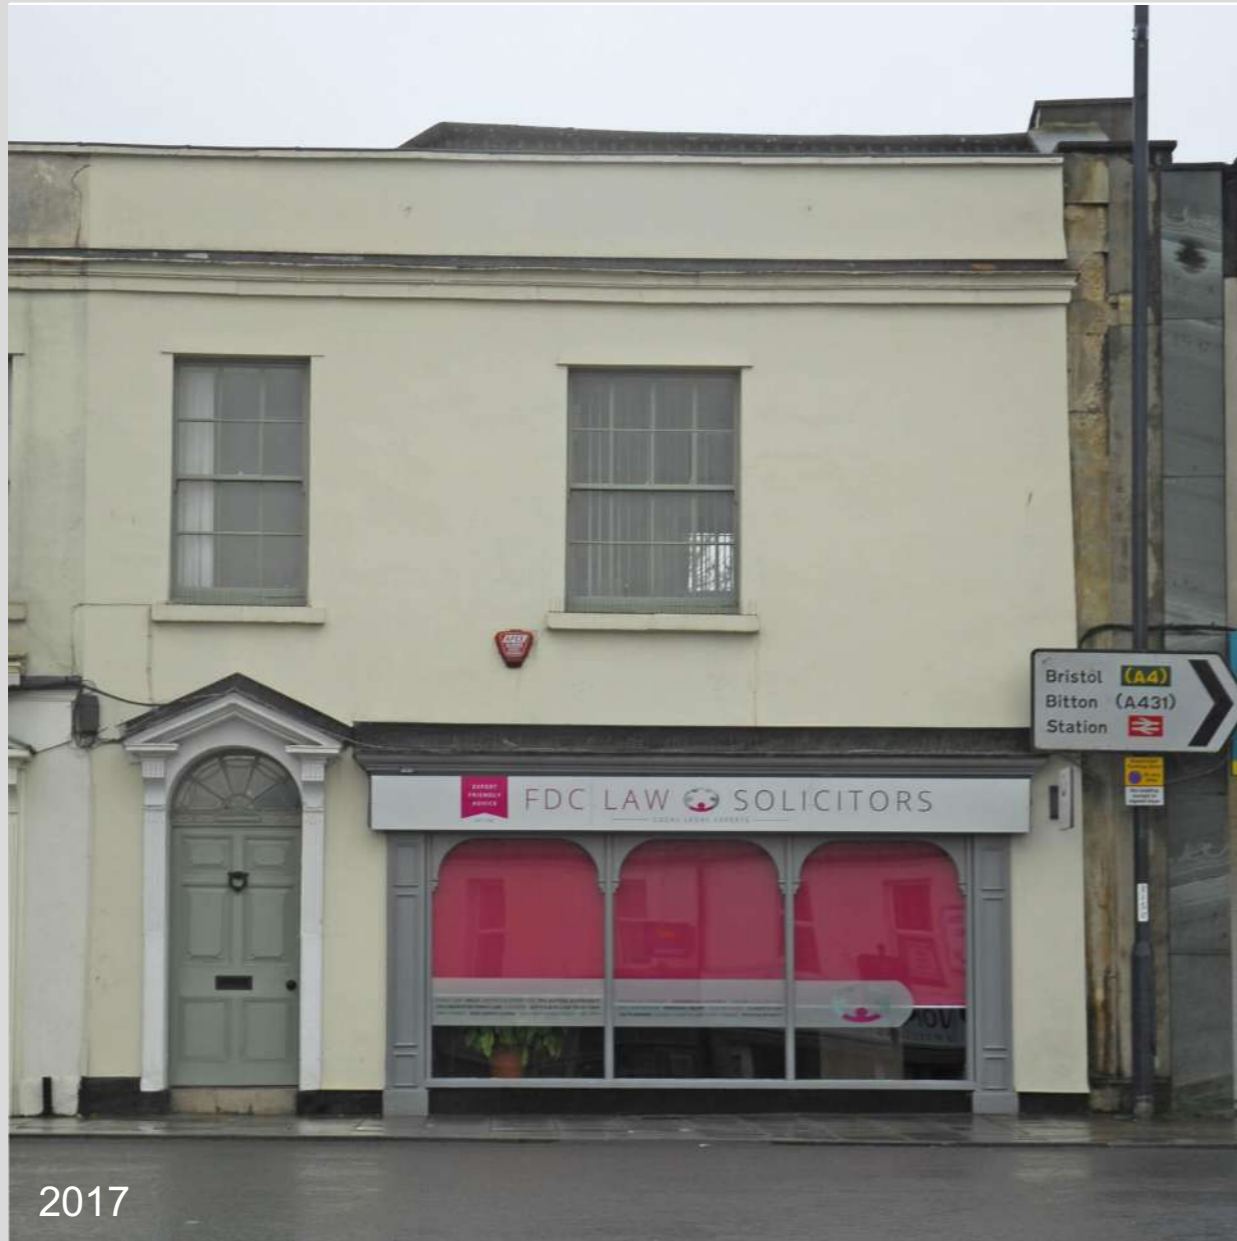
2017

Two uneven first floor windows, 6/6 (left) and 8/8 (right), with horned timber sashes sit over a broken pedimented entrance door and planted shopfront respectively. The doorcase, door and fanlight are all intact and original.

The planted timber arcaded shopfront is a post 1980's intervention and lacks any real style but improves on the previous openings. The signage sits awkwardly on the fascia running beyond the pilaster lines but this may be due to the construction of the frontage.

The building retains a substantial amount of character and is well maintained. Unfortunately it has not been treated as one with No 66 which is less well maintained. The shop frontage whilst sympathetic is swamped by the signage which is too big.

This building forms part of a pairing. Both buildings should be considered as a group when being maintained and alterations are being made to ensure the buildings complement each other.

- Construct capitals or corbels to pilasters
- Remove surface mounted cables
- Decorate in conjunction with 66
