STREETSCAPE AND DETAILS

45 HIGH STREET, KEYNSHAM

53 HIGH STREET, KEYNSHAM

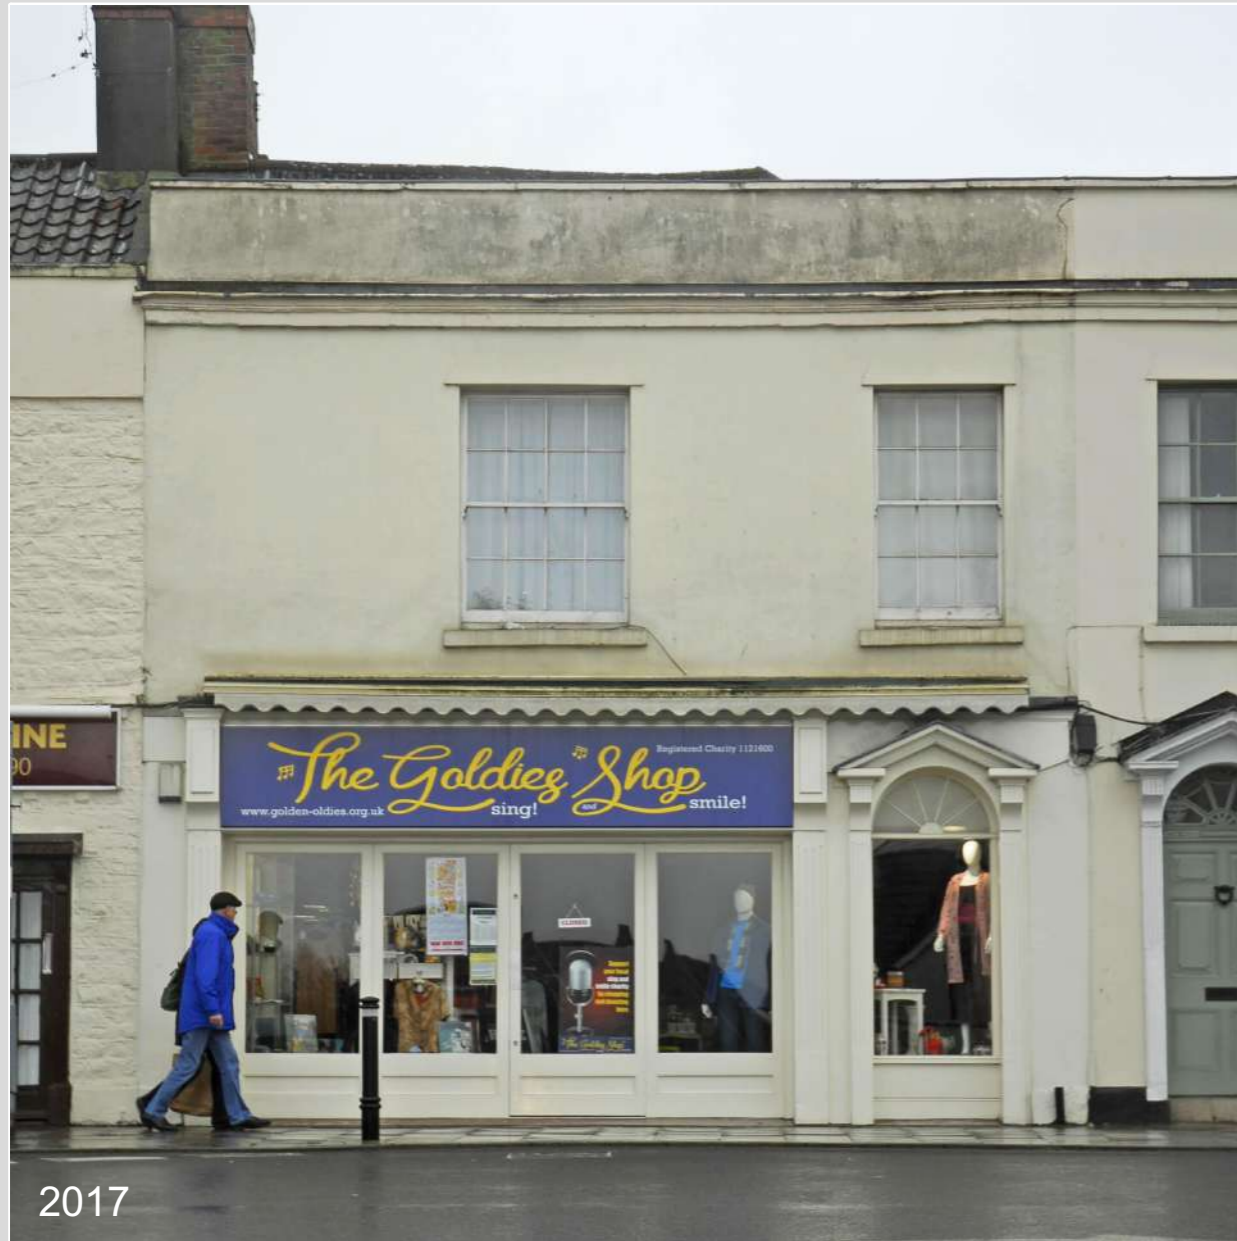
2017

Two uneven first floor windows, 6/6 (right) and 8/8 (left), with horned timber sashes sit over a modern broken pedimented entrance door and planted shopfront respectively. None of the doorcase, door and fanlight are original.

The planted timber shopfront is a post 1980's intervention and lacks any real style but improves on the previous openings. The deep plastic fascia signage sits awkwardly on the fascia

The building retains a substantial amount of character and is reasonably maintained. Unfortunately it has not been treated as one with No 64 which is well maintained. The shop frontage whilst sympathetic is dominated by the signage which is too deep and the awning over-sails the primary shop front on the elevation confusing the architecture.

This building forms part of a pairing. Both buildings should be considered as a group when being maintained and alterations are being made to ensure the buildings complement each other.

- Change signage from plastic to traditional sign writing
- Reduce awning length, and relocated to between console brackets
- Decorate in conjunction with 64
- Pick out shop joinery in a contrasting colour
- Reintroduce door in original location

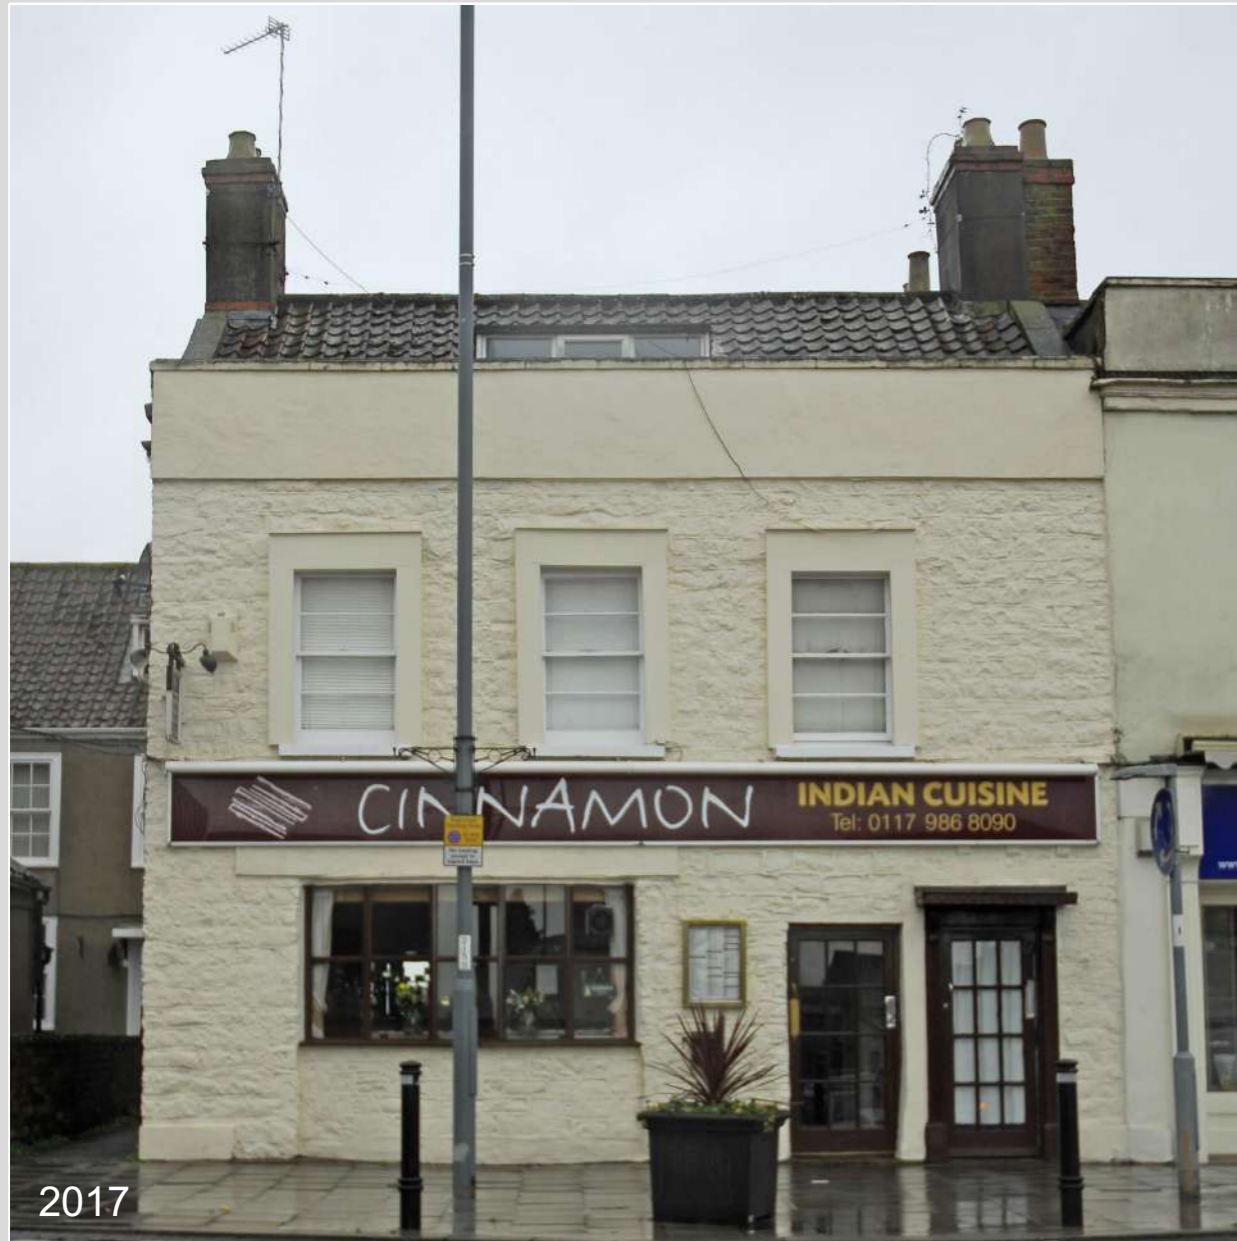
2017

The former openings at ground level with the exception of the door to the far right have been reconfigured with poorly detailed alterations.

There have been a number of inappropriate alterations to the building including timber boxing out of the window reveals and over-rendering of the upper parapet wall making the architectural detailing clumsy. The planting of plastic signage over an existing stone fascia is also unfortunate as is the treatment of new openings. The building is well maintained but the colour washing is likely to conceal some problematic areas and dilutes the architecture.

This is a highly prominent building requiring enhancement.

- Remove paint from masonry to reveal rubble work
- Remove timber boxing from around first floor windows and clean ashlar surrounds and cill
- Remove plastic signage to reveal stone fascia.
- Remove rendering from parapet or limewash
- Consider planting shop front in place of bay window to relate to windows above, conceal unsightly lintel and ground elevation
- Form hood moulding to restaurant door to unify the doors

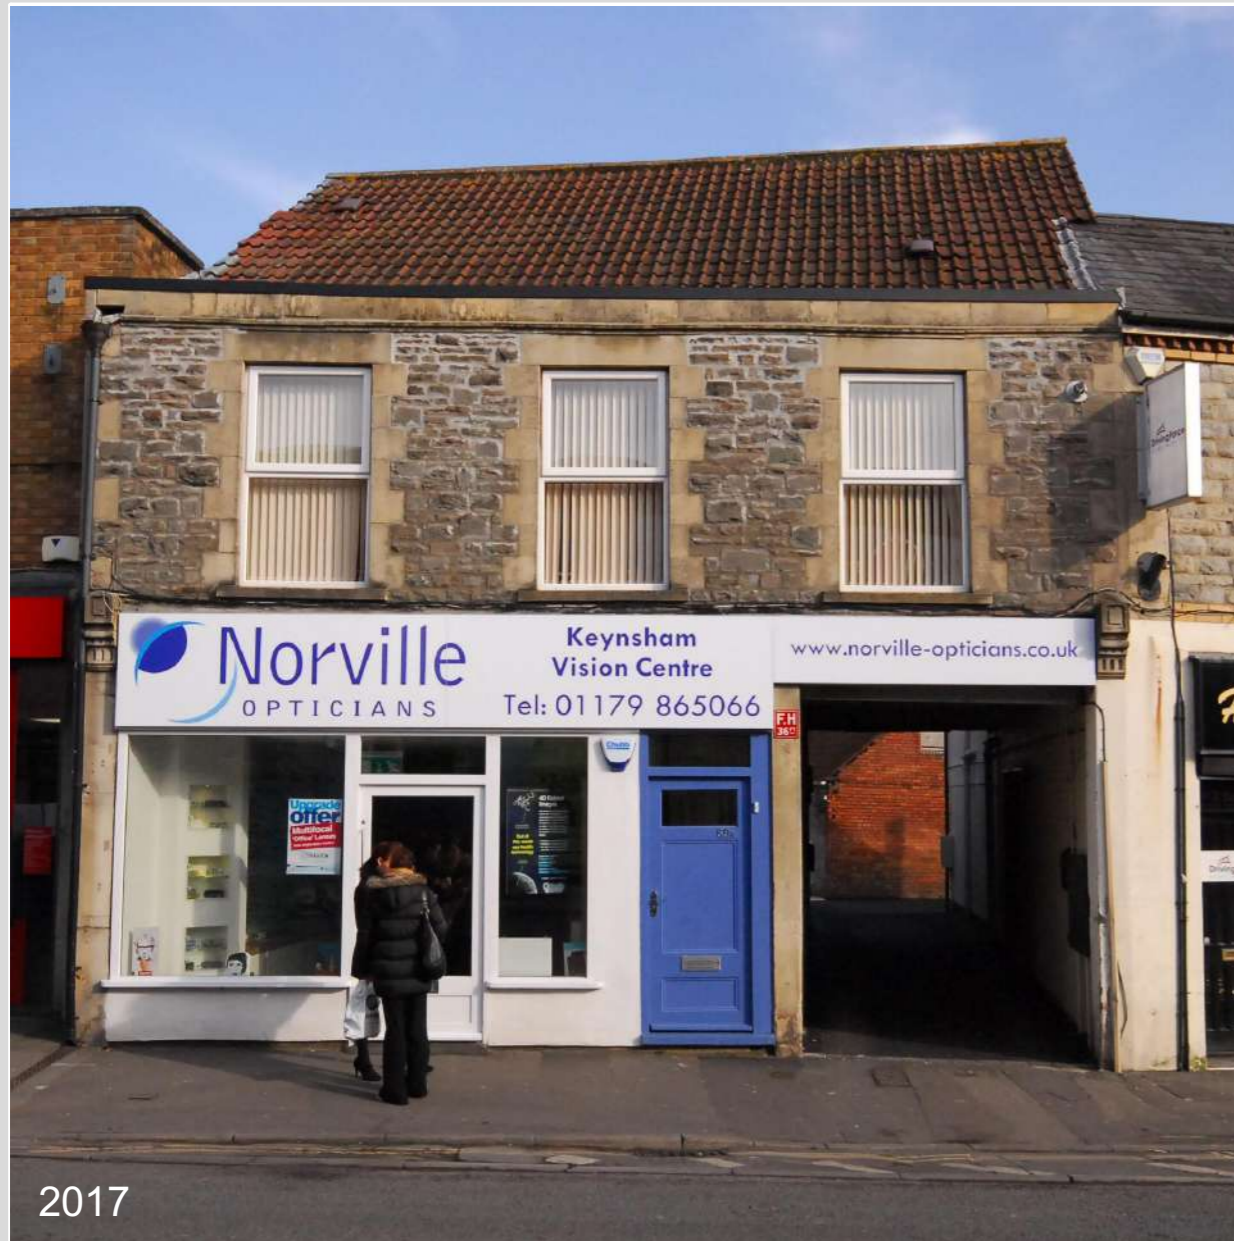
2017

There are areas of poor maintenance including cement pointing.

This building was purpose built as a shop with accommodation above. Although relatively intact in form the elevation has been compromised with the introduction of a side door to the upper floor apartment and the remodelling of the original shop front. The plastic fascia signage extending over the elevation is ill-considered and oversized. The cement pointing is appropriate and may cause damage to the stonework.

- Add additional console bracket to left of passage
- Contain signage to width of shop front. Do not take over passageway
- Reduce depth of fascia to relate to console brackets and replace with traditional painted signs
- Consider a new planted shop frontage with central door
