# MEMO

<b>TO</b>	Gary Peacock – Bath and North East Somerset Council Dale Mynett – Bath and North East Somerset Council	<b>FROM</b>	Liam Hennessey - WSP
<b>DATE</b>	28 March 2022	<b>CONFIDENTIALITY</b>	Public
<b>SUBJECT</b>	Cleveland Bridge – Truss 4 North End – Support Defect – Interim Commentary

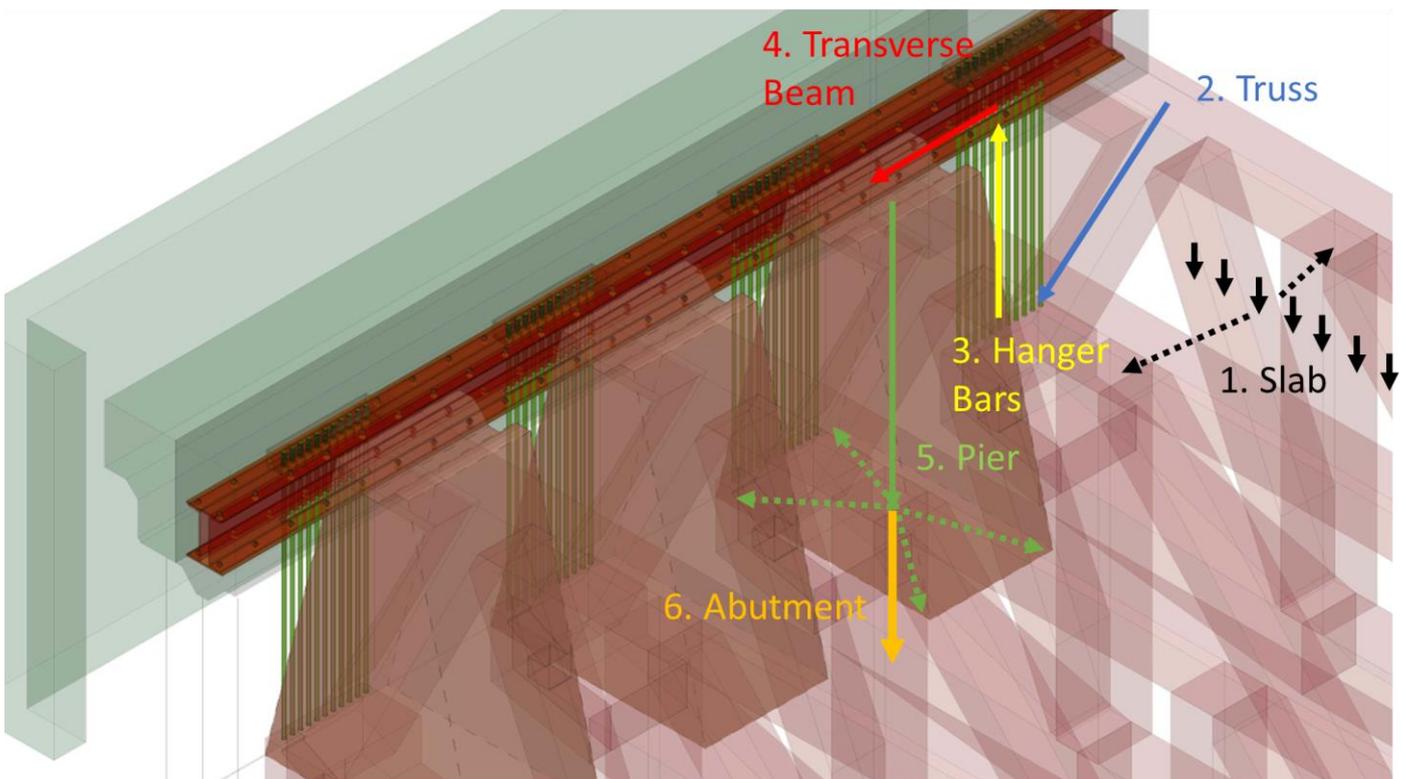
The replacement deck system of Cleveland bridge was constructed in 1929 and is extremely novel in terms of its design and detailing. Figure 1 illustrates the structural arrangement at one end of the deck. The loads from the reinforced concrete deck slab (1) are carried by 4 reinforced concrete trusses (2) and transferred into the abutments by groups of 11 exposed hanger bars (3), via a transverse beam (4), which is supported on mass concrete piers (5) that protrude from the abutment (6). There are therefore 88 hanger bars in total across the structure.

Figure 1 - Generalised load path arrangement.

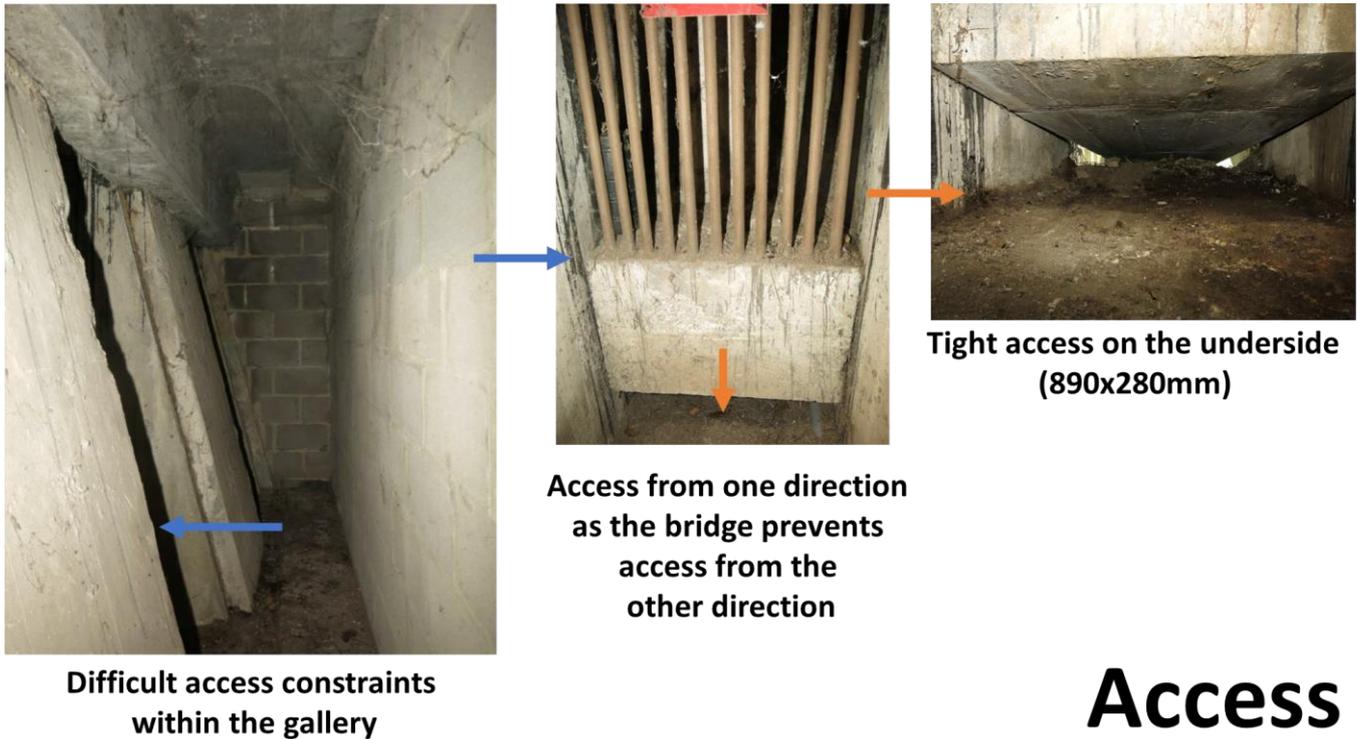
Assessment activities to date have been focussed on the superstructure of the bridge and there is limited reliable data available with regards to the make-up of the historic abutment structure and its ability to accommodate any secondary load transfer through any alternative support system beneath the ends of the lower chords. Additionally, there are practical constraints, such as access within the abutment galleries (Figure 4), which will be a key factor in the evaluation of viable mitigation measures that might be installed to ensure the ongoing safety of the structure. Specialist contractor advice has been sought to begin to progress potential option development.

*Figure 4 - Access considerations.*

3. The feasibility study should be further developed to identify viable options for remedial works that will mitigate the risk of failure of the corroded hanger bars. The study will consider and evaluate the merits of installing a passive, failsafe support system in parallel with the ongoing monitoring system against the potential risks associated with the option of providing an active, alternative support system via bearings installed beneath the truss bottom chord. The detailed design of the preferred option will be covered by a separate Approval in Principal process and subject to an appropriate level of checking.
